# Manhole Inspection Summary

Manhole # S47E2\_016MH

Insp Date: **1/24/08 1:06 PM**

**Location** Address: **3901 Curtis Ave.**

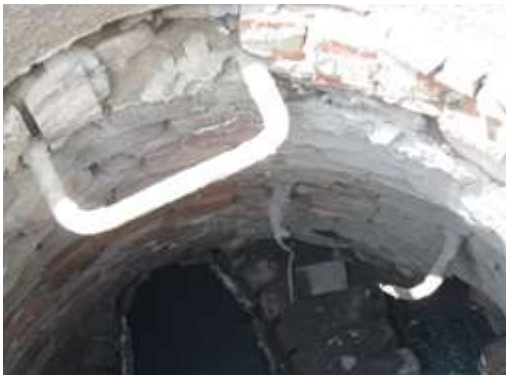
Steps

Count: **2** Missing: **1** ☒ Corroded

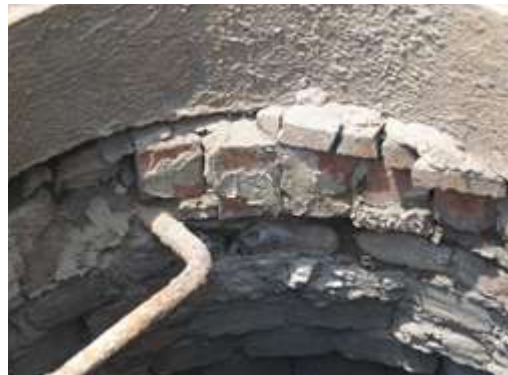
Defect 1

Condition: ☐ Sound ☐ Cracked ☐ Root Intrusion ☒ Loose Brick ☒ Deteriorated

Infiltration: ☐ None ☒ Joint ☐ Cracks ☒ Mortar ☐ Roots ☐ Wall

Chimney infiltration

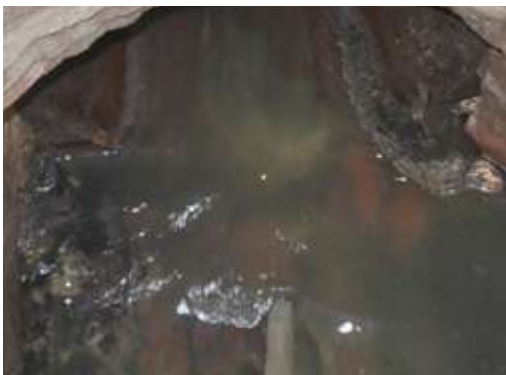
Defect 2

Condition: ☐ Sound ☐ Cracked ☐ Root Intrusion ☐ Deteriorated ☐ Leaks ☒ Debris

Waste in channel

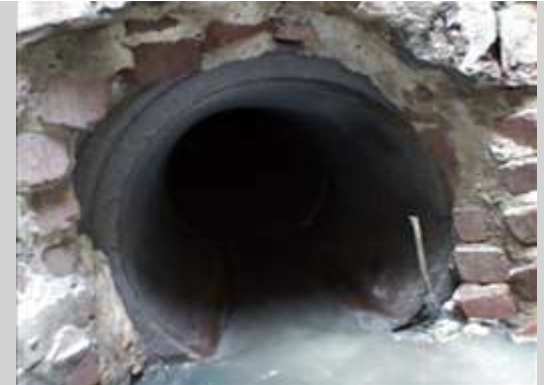
12 O'Clock Outflow

Pipe Height: **18** (in.) Rod and Bar (Angled)  
Pipe Material: **Clay** ☐ Pipe Lined  
Invert Depth: **6.34** (ft.) Flow Characteristics: **Fast**  
Deposits: ☒ None ☐ Mud ☐ Sludge ☐ Debris ☐ Grease  
Silt Depth: (in.) Deposits Extent:  
Infiltration: **None** Pipe Seal Cond: **Sound**

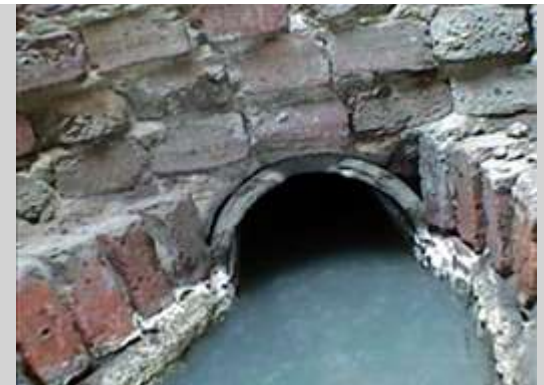
5 O'Clock Inflow

Pipe Height: **8.4** (in.) Rod and Bar (Angled)  
Pipe Material: **Clay** ☐ Pipe Lined  
Invert Depth: **5.92** (ft.) Flow Characteristics: **Slow**  
Deposits: ☒ None ☐ Mud ☐ Sludge ☐ Debris ☐ Grease  
Silt Depth: (in.) Deposits Extent:  
Infiltration: **None** Pipe Seal Cond: **Sound**

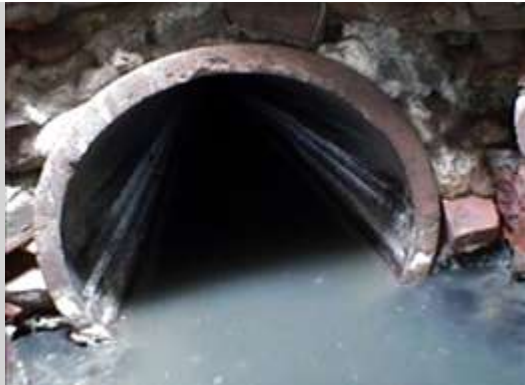
7 O'Clock Inflow

Pipe Height: **14.4** (in.) Rod and Bar (Angled)

Infiltration: **None** Pipe Seal Cond: **Sound**
